NORRIS WOODS CREEK STABILIZATION AND WATER QUALITY IMPROVEMENT PROJECT

Norris Woods Creek Stabilization
and
Water Quality Improvement Project

Soil Erosion and Sediment Control Plan

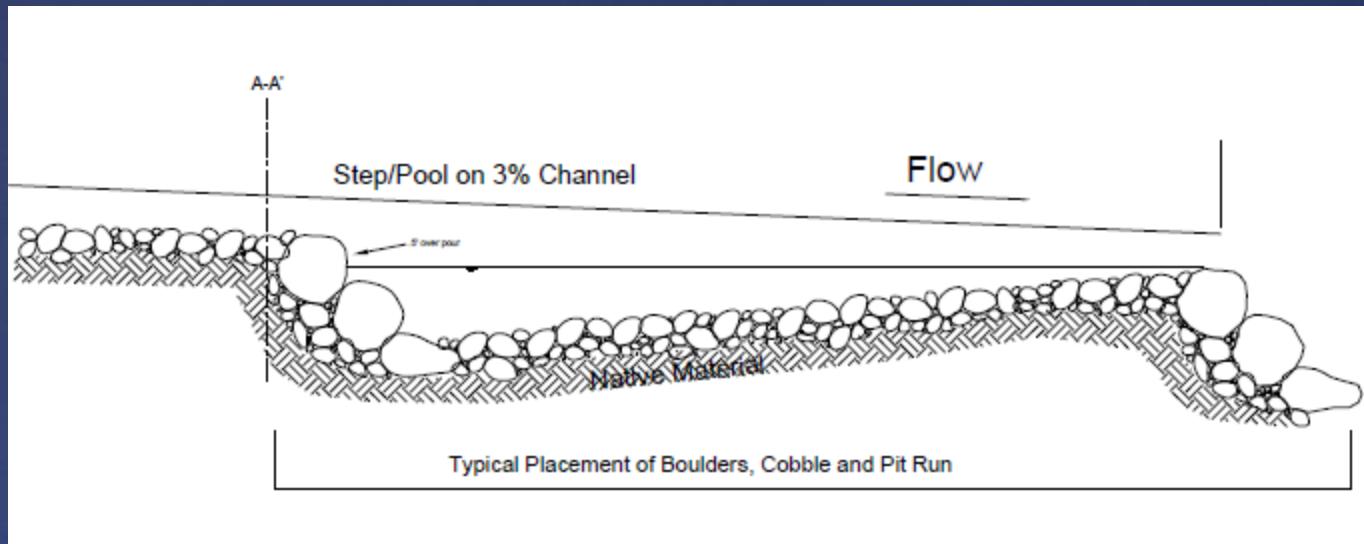
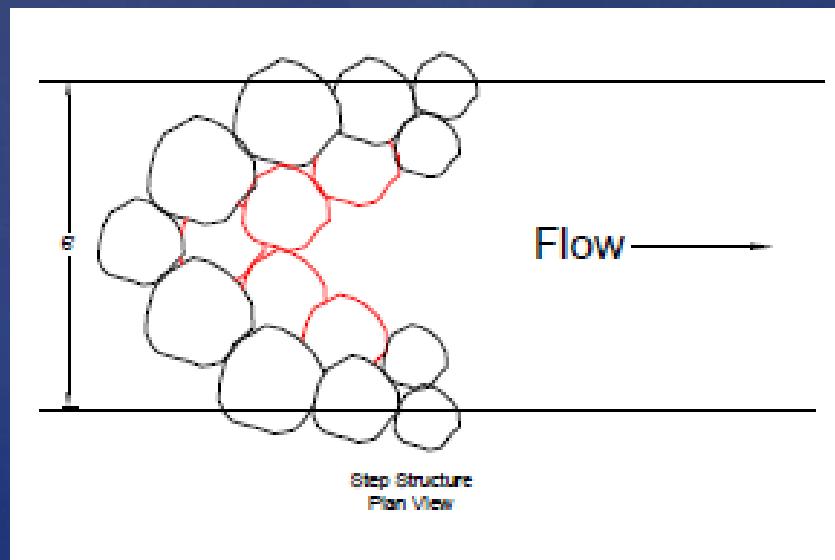
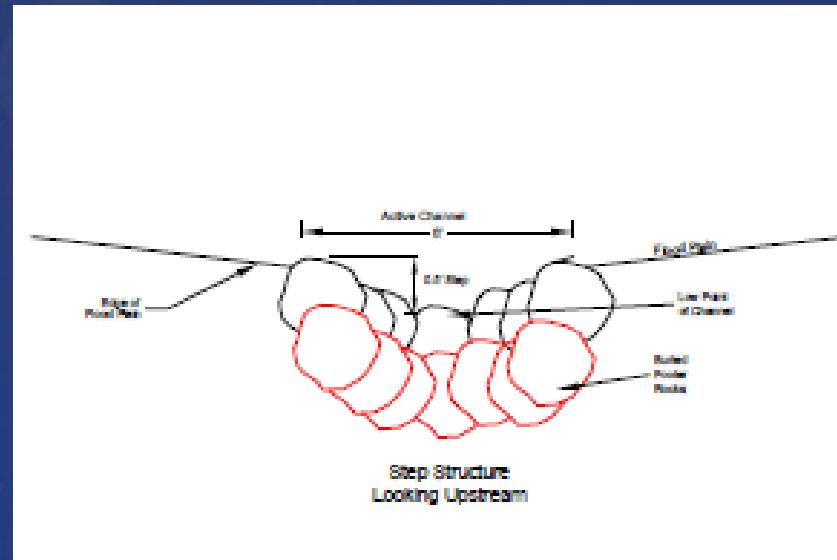
Typical Step/Pool Stabilization Structures

Step/pool structures were installed to stabilize the creek bed as well as its banks allowing sediments and associated pollutants to settle out and slow the flow of water moving through the system.

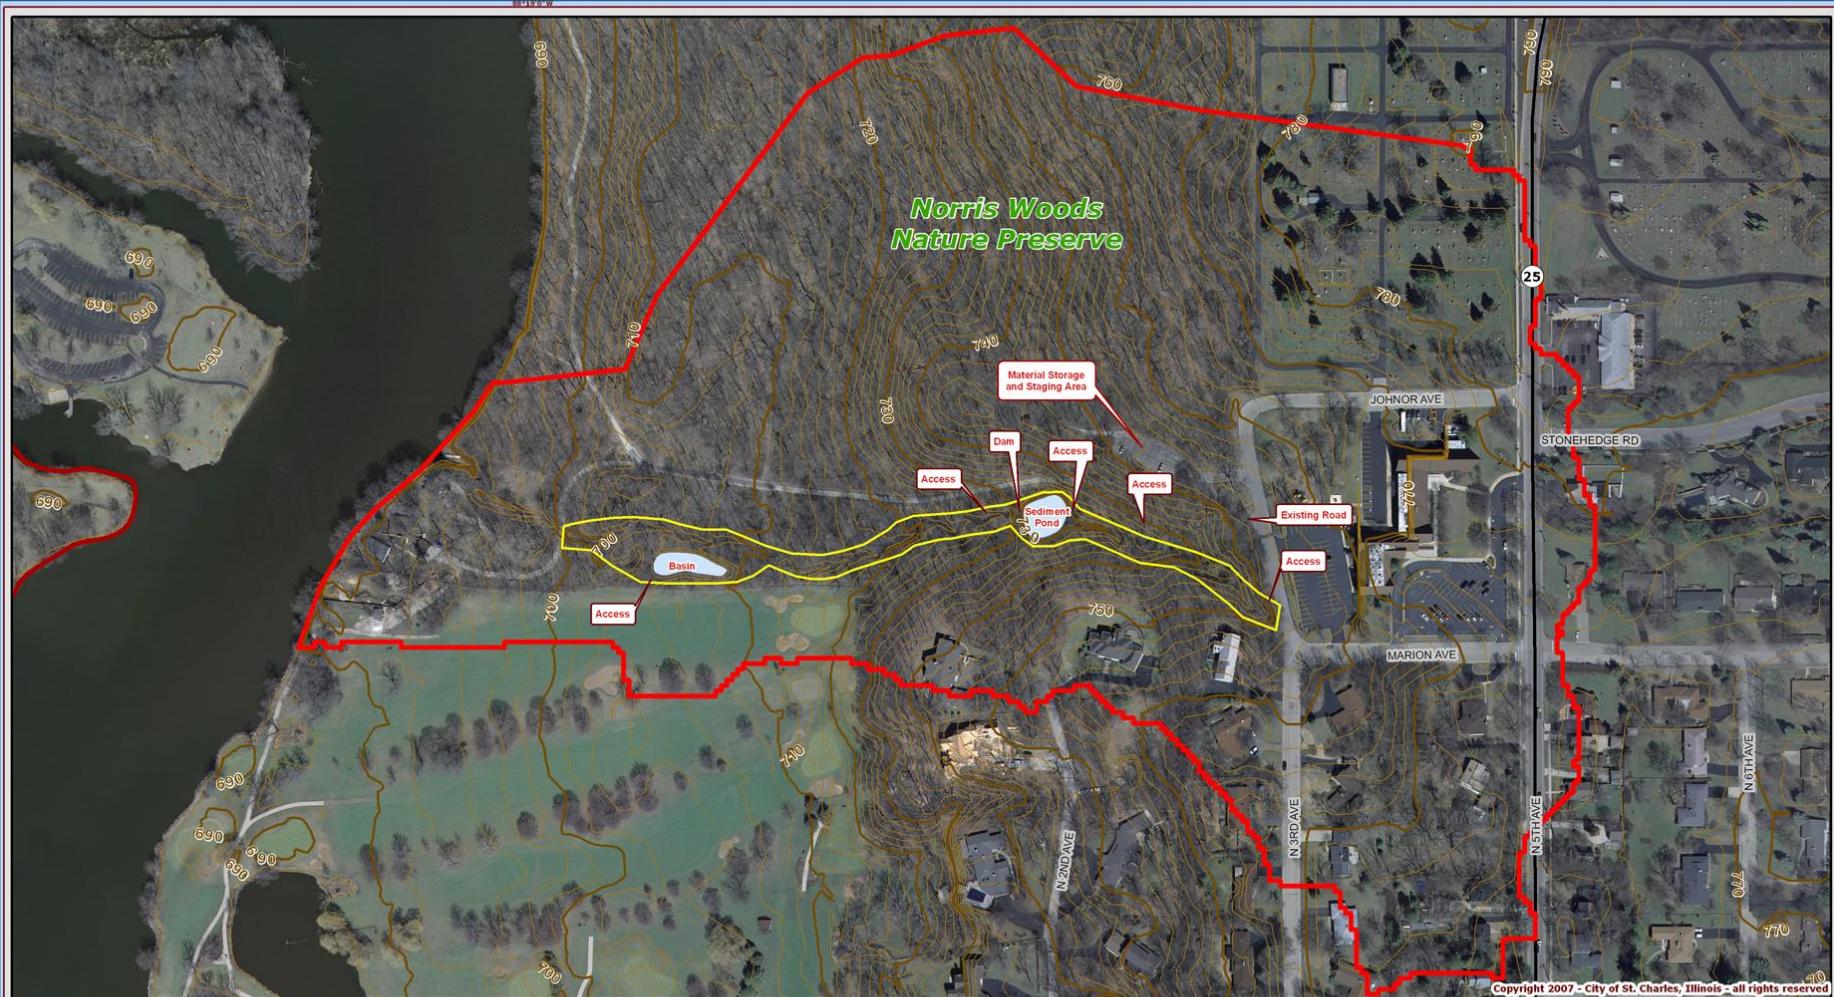
Watershed Basin Statistics
47% Natural Area
53% Developed
Square Feet: 2,289,252
Acres: 53
Square Miles: 0.08

Work Area Statistics
Square Feet: 84,131
Acres: 1.93

Watershed Basin
Work Area
Basin and Sediment Pond Area

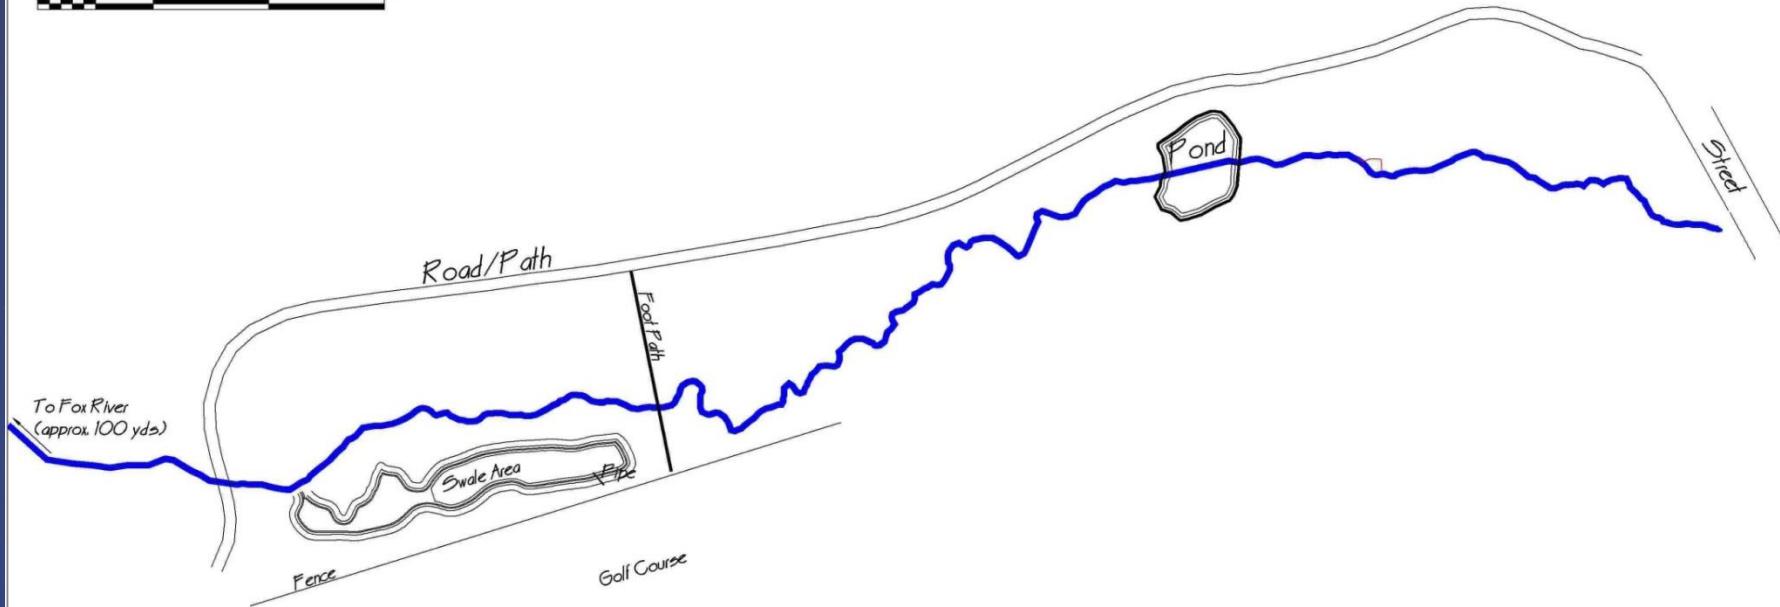
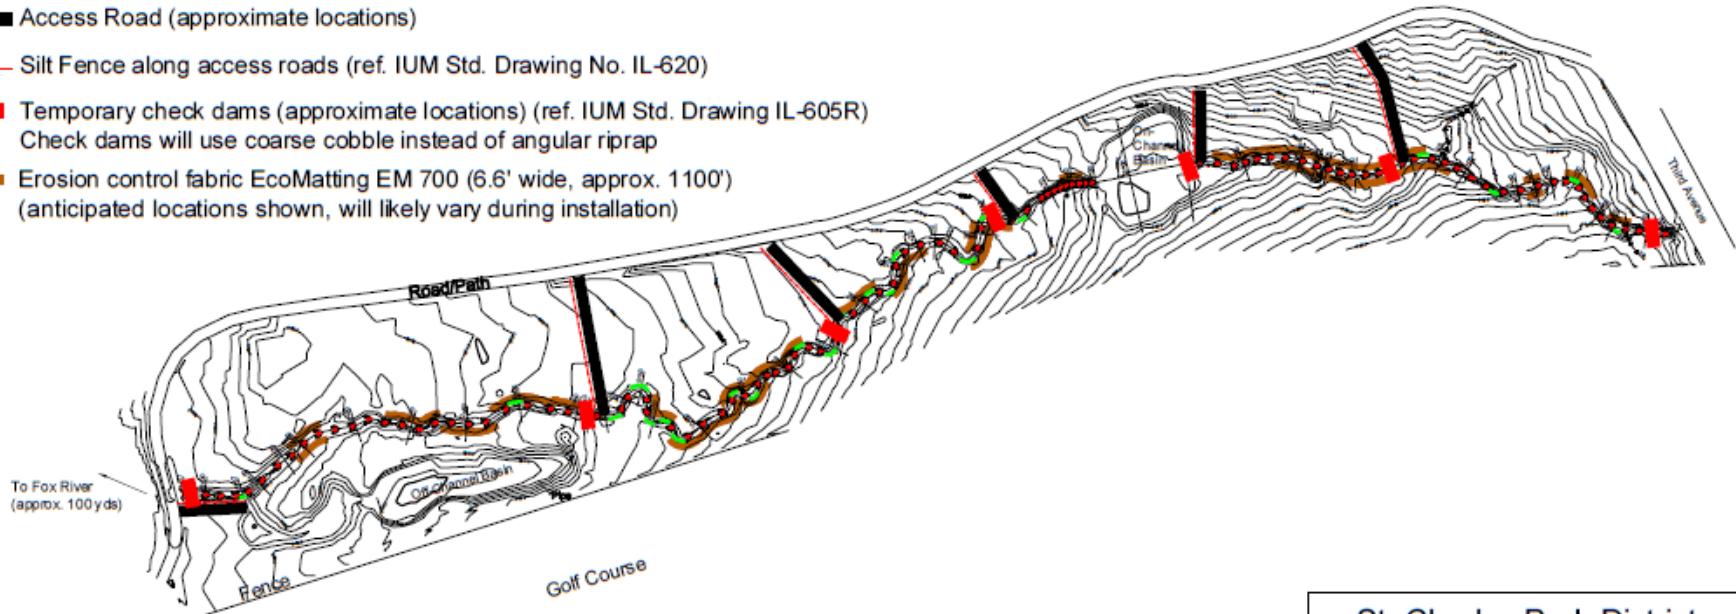
- Symbols indicate approximate locations of proposed rock steps. Steps will be field-fit during construction.

- Symbols indicate areas that may need additional bank protection on outside bends. To be determined during construction.

Access Road (approximate locations)

Silt Fence along access roads (ref. IUM Std. Drawing No. IL-620)

Temporary check dams (approximate locations) (ref. IUM Std. Drawing IL-605R)
Check dams will use coarse cobble instead of angular riprap

Erosion control fabric EcoMatting EM 700 (6.6' wide, approx. 1100')
(anticipated locations shown, will likely vary during installation)

Cross Station	Bed Grade TOB Elevation (ft)	Reach Length (ft)	Vertical Fall (ft)	Channel Segments		Step Spacing (ft)		
				No. of Steps in Reach	Step Width (%)			
Inlet	0	708.8	702.0	4.0%	256	10.1	20	12
	328	697.2	695.4	4.0%	78	3.82	7	11
	358	695.8	693.9	4.0%	170	0.39	1	12
	398	694.2	693.4	4.0%	15	0.81	1	12
	408	694.2	693.4	4.0%	58	2.02	6	12
	448	692.7	693.9	3.67%	48	5.47	3	14
	468	692.7	693.9	3.67%	16	0	0	12
	508	692.7	693.9	0.0%	66	0	0	58
	538	693.0	694.2	-1.0%	38	0.3	0	38
	578	693.2	679.4	18.67%	48	4.8	10	5
	723	694.0	679.4	2.84%	147	4.2	5	17
	903	695.5	670.7	2.84%	121	4.5	9	15
	915	695.8	687.0	3.0%	122	3.7	7	18
	1043	695.0	686.2	2.54%	268	6.8	16	28
	1487	692.1	683.3	3.08%	244	8.8	18	18
Total	1518	694.8	682.0	2.66%	51	1.35	9	18
				101	10.1

Topography shown was drawn from a topographic survey data obtained in March 2007.
Arbitrary elevation datum.

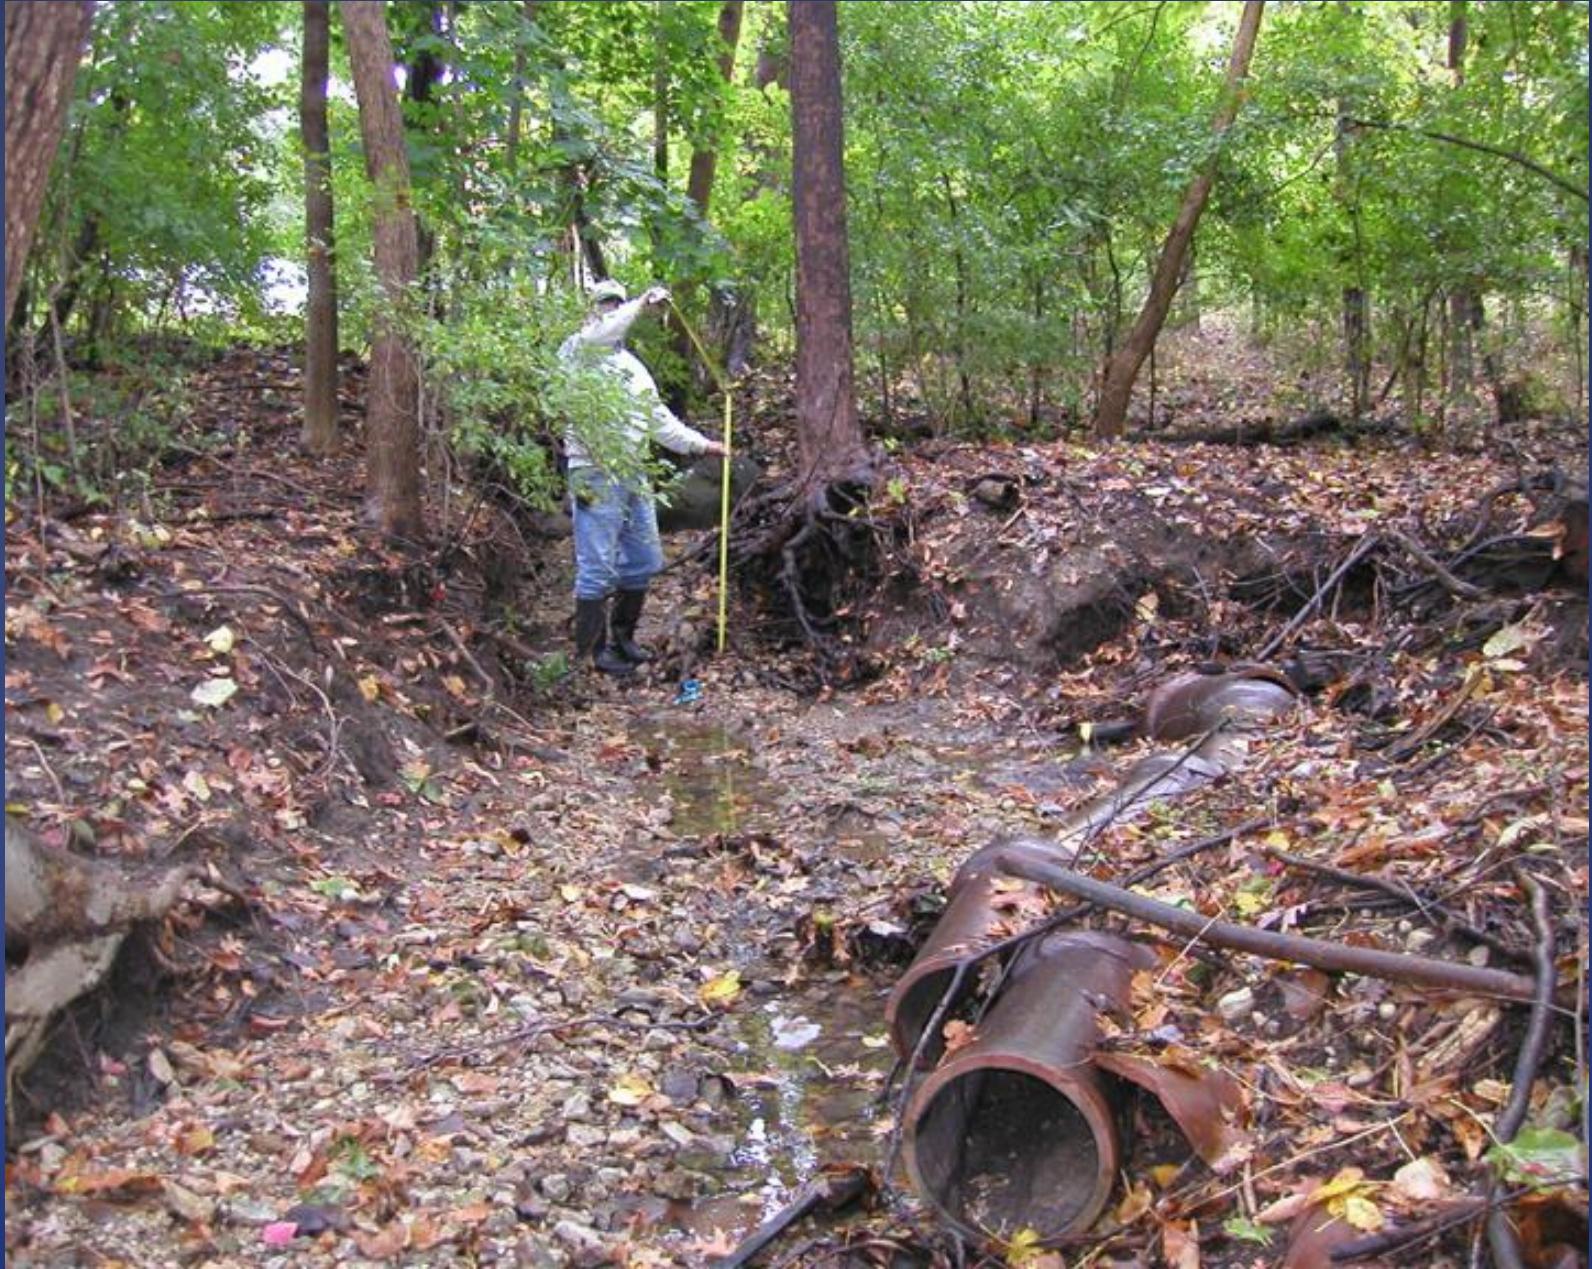
An example of serious bank and bed erosion.

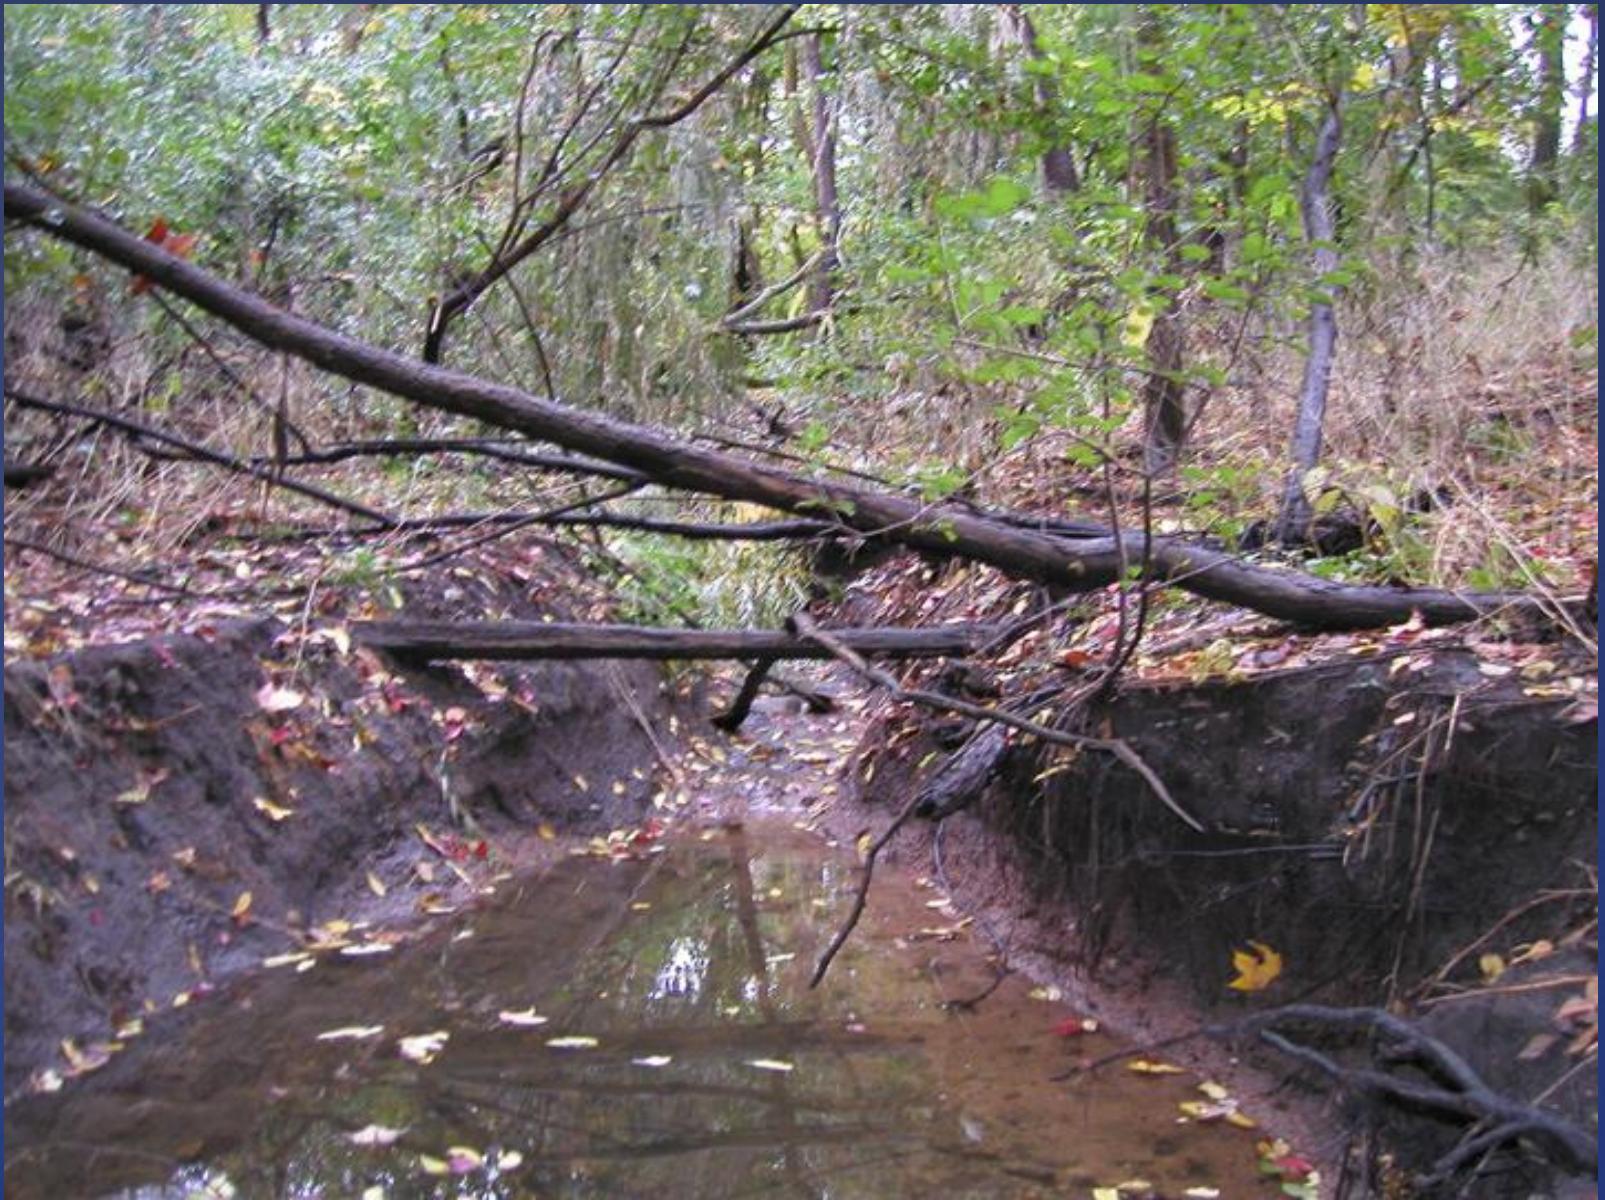
An example of serious channel cutting.

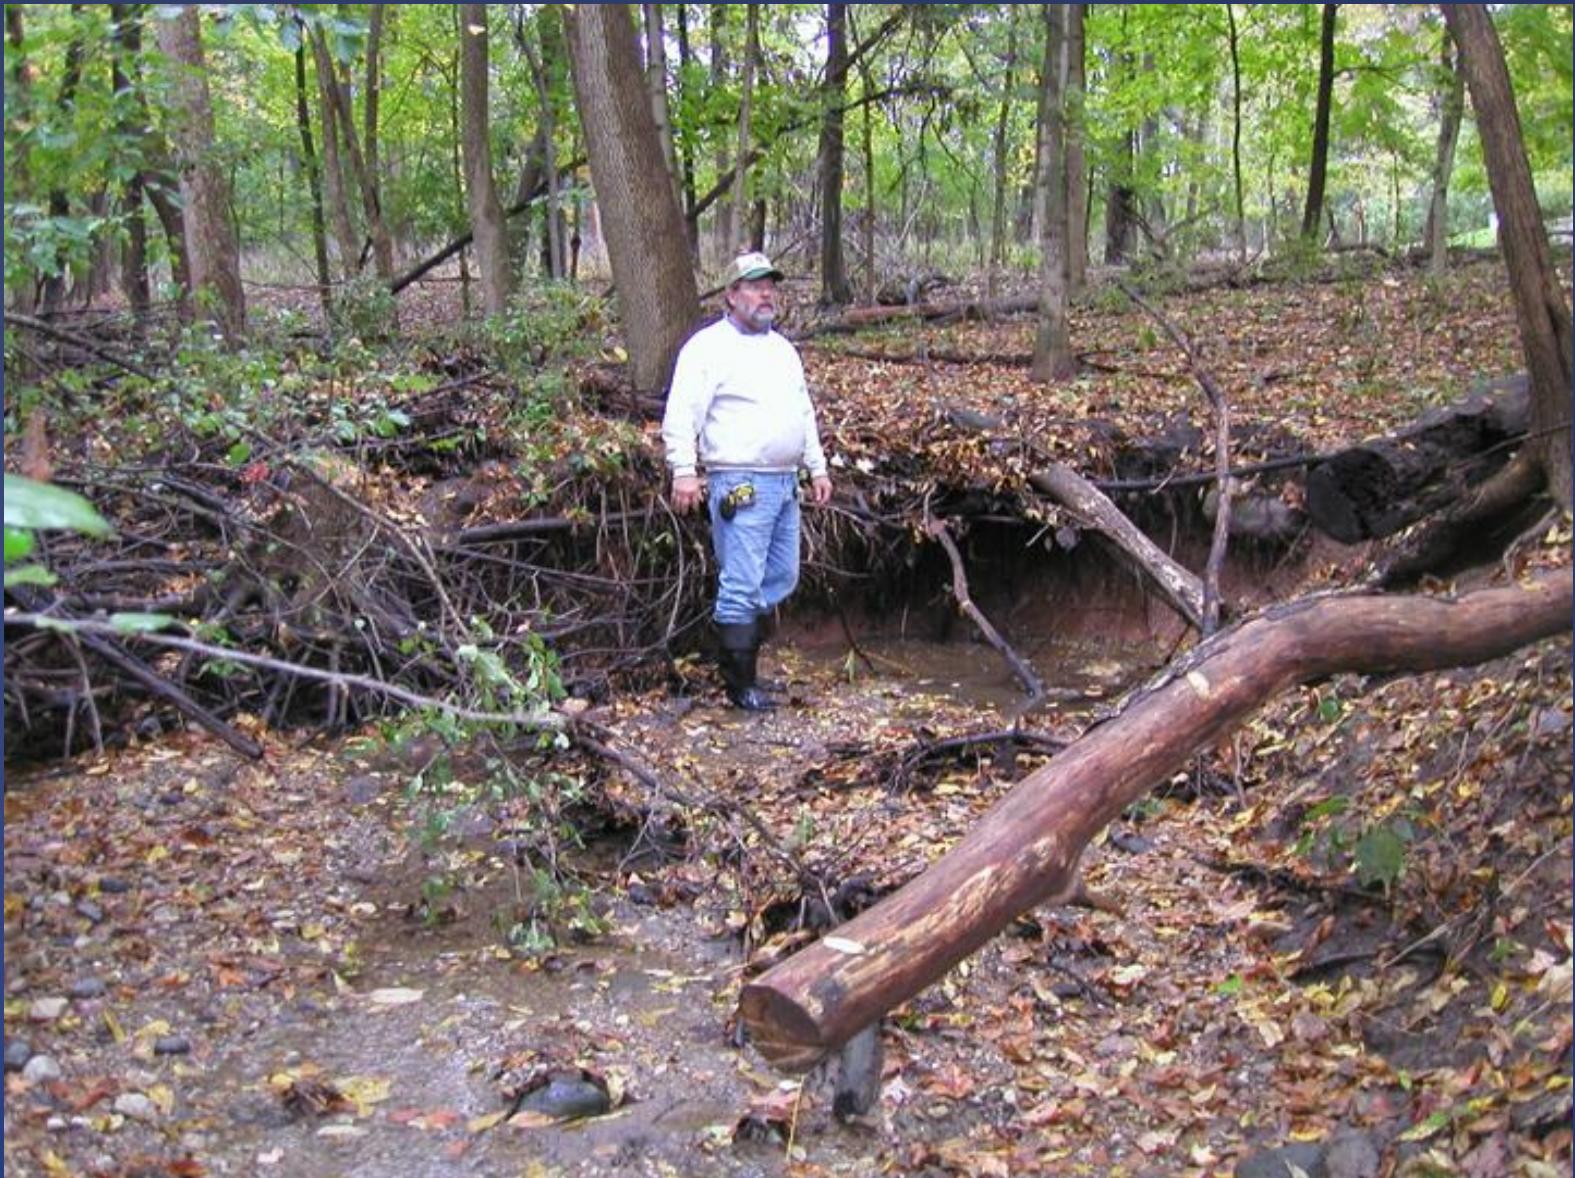
Flooding led to multiple channels head-cutting at this point.

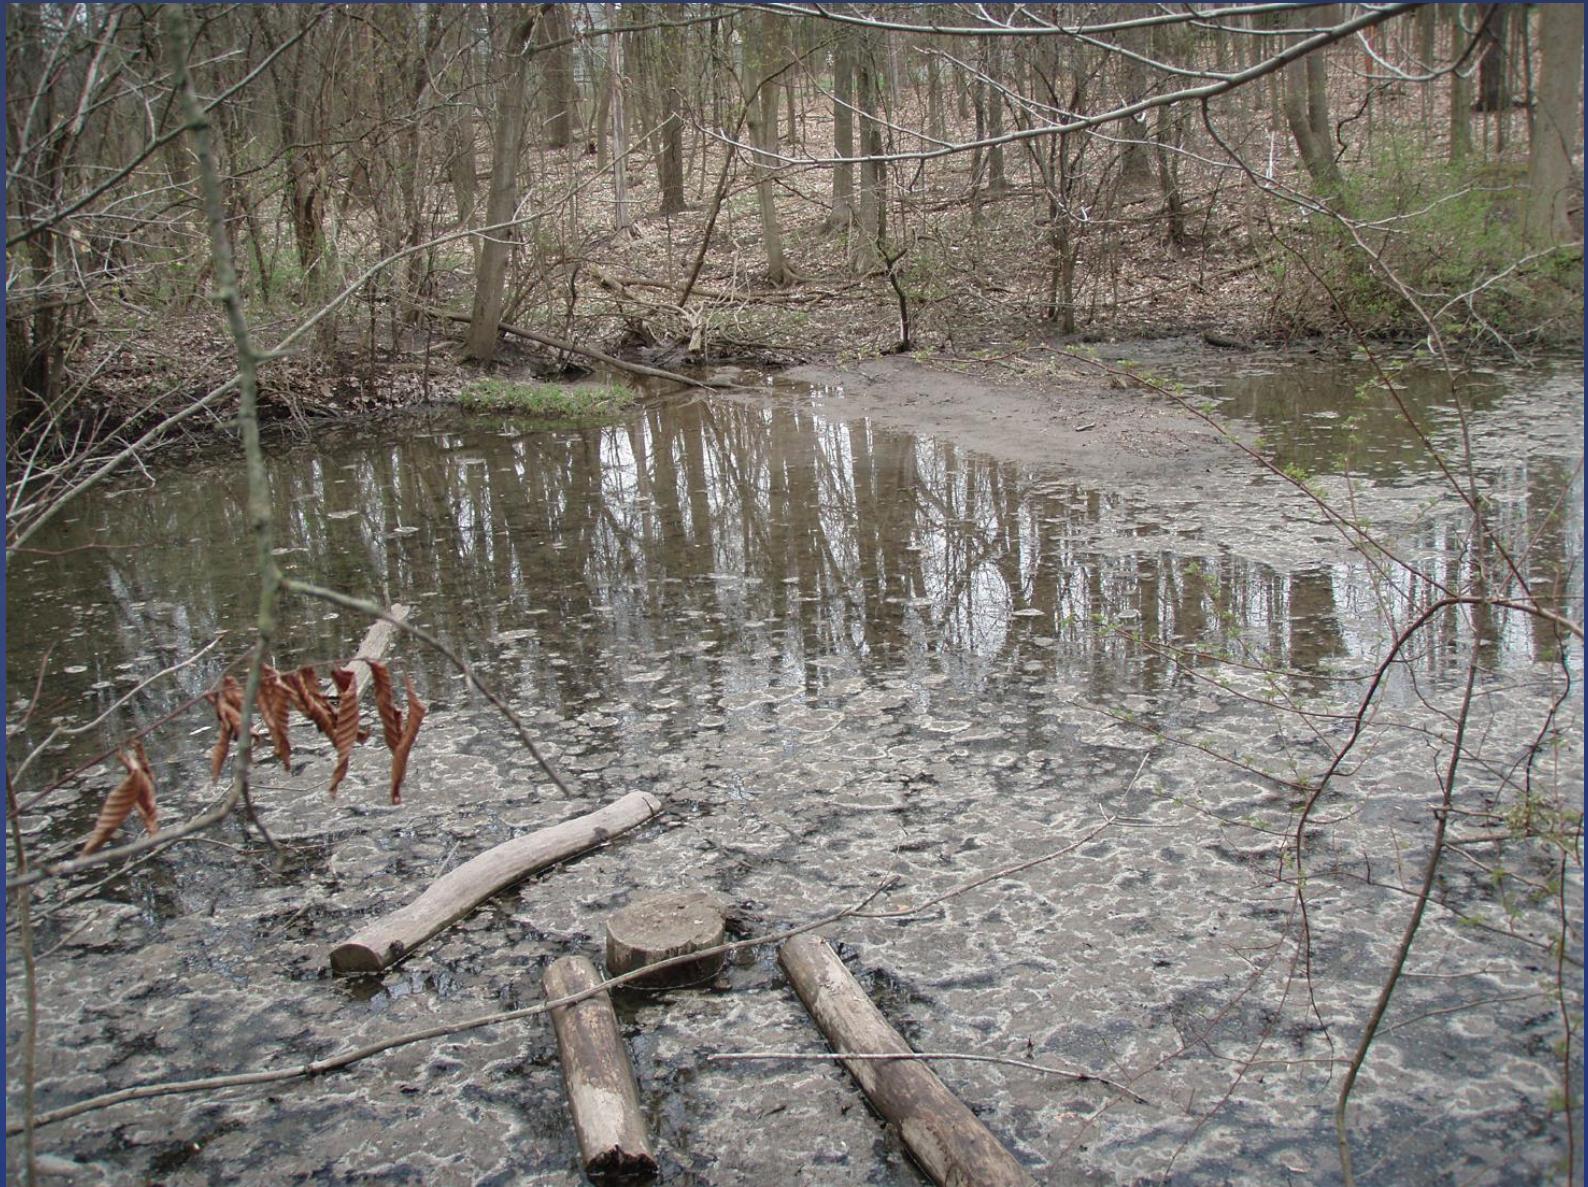
An example of sediment deposition in the in-channel basin.

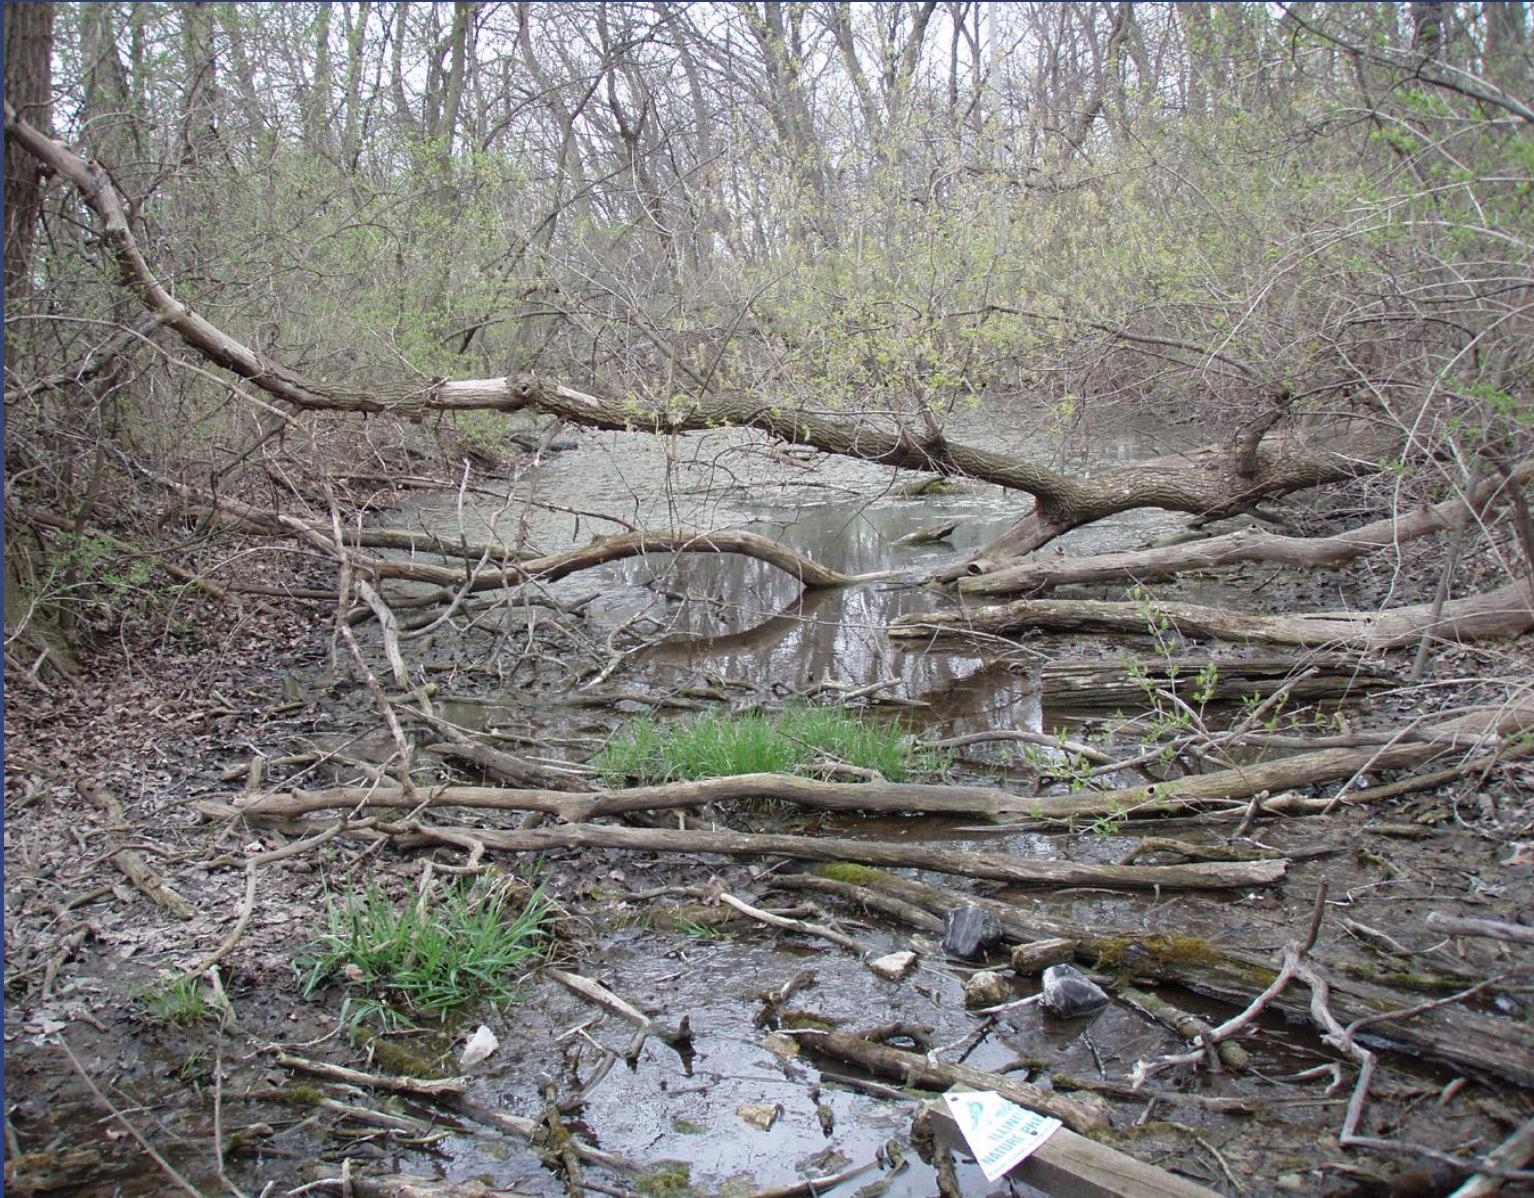
The off-channel basin filled with debris.

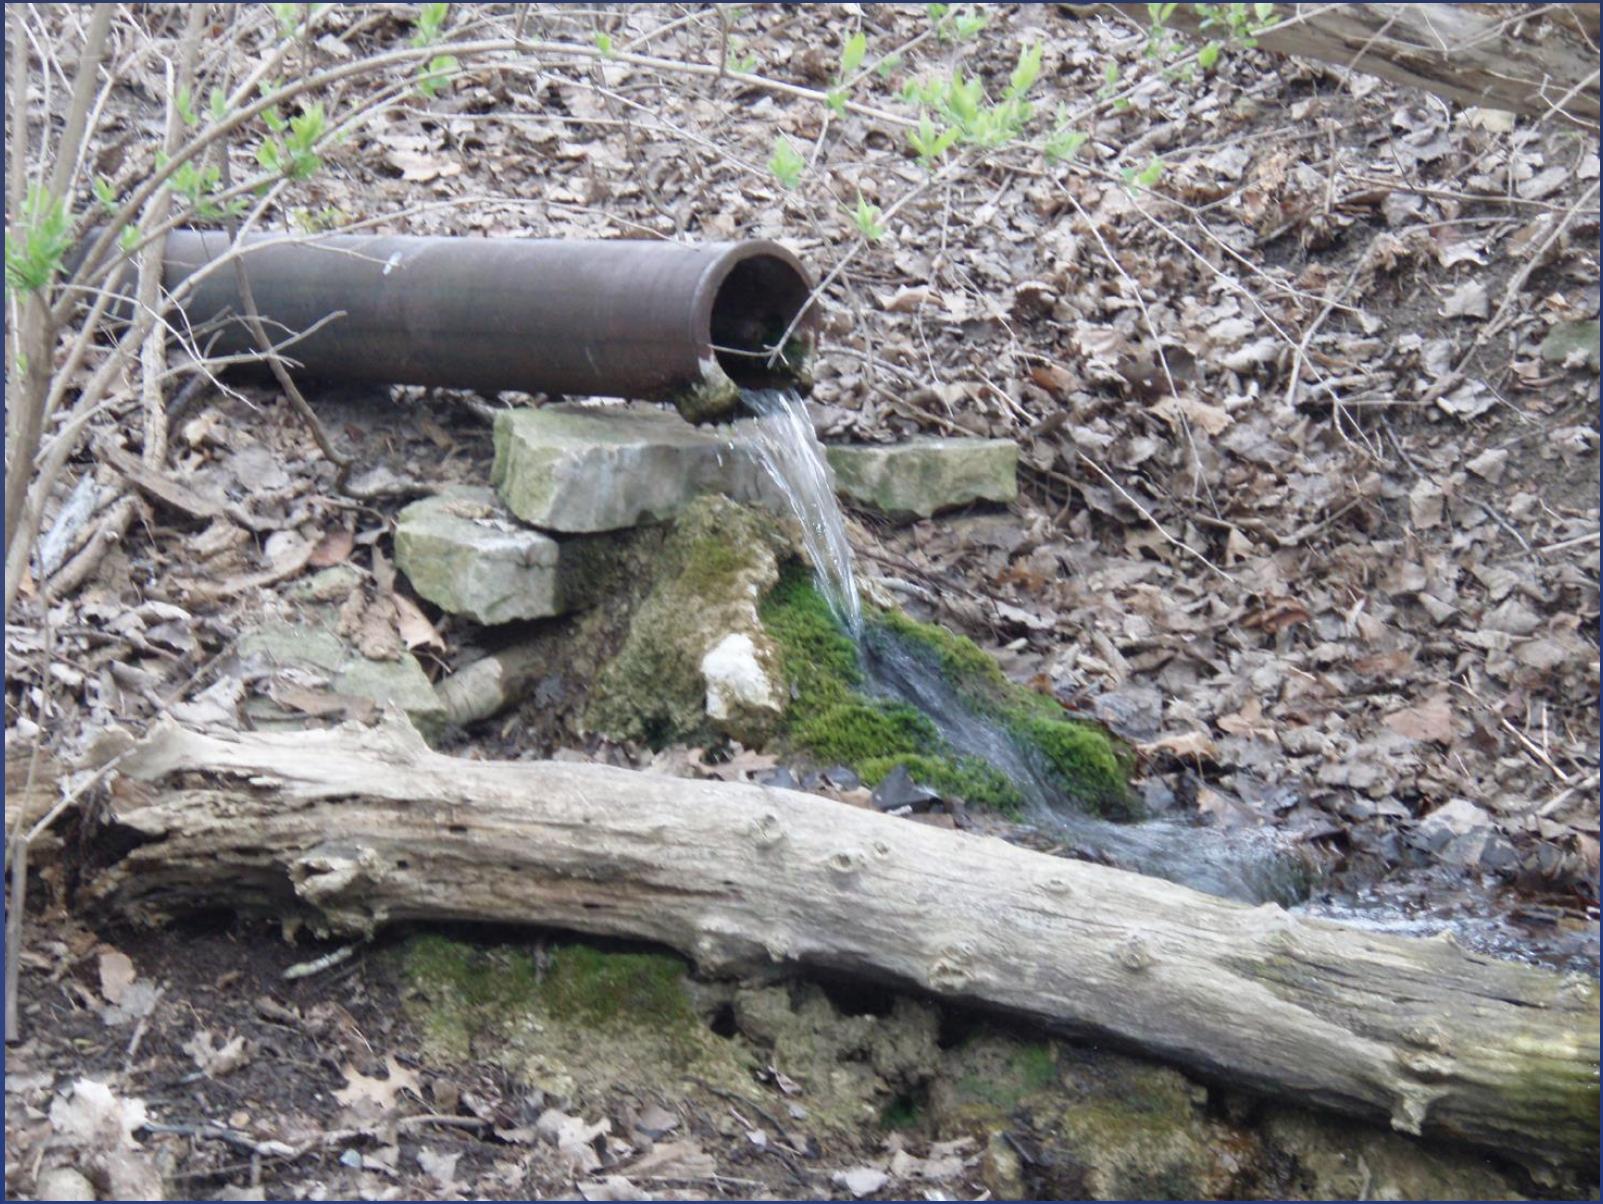
One of three water sources leading into the off-channel basin from the adjacent golf course.

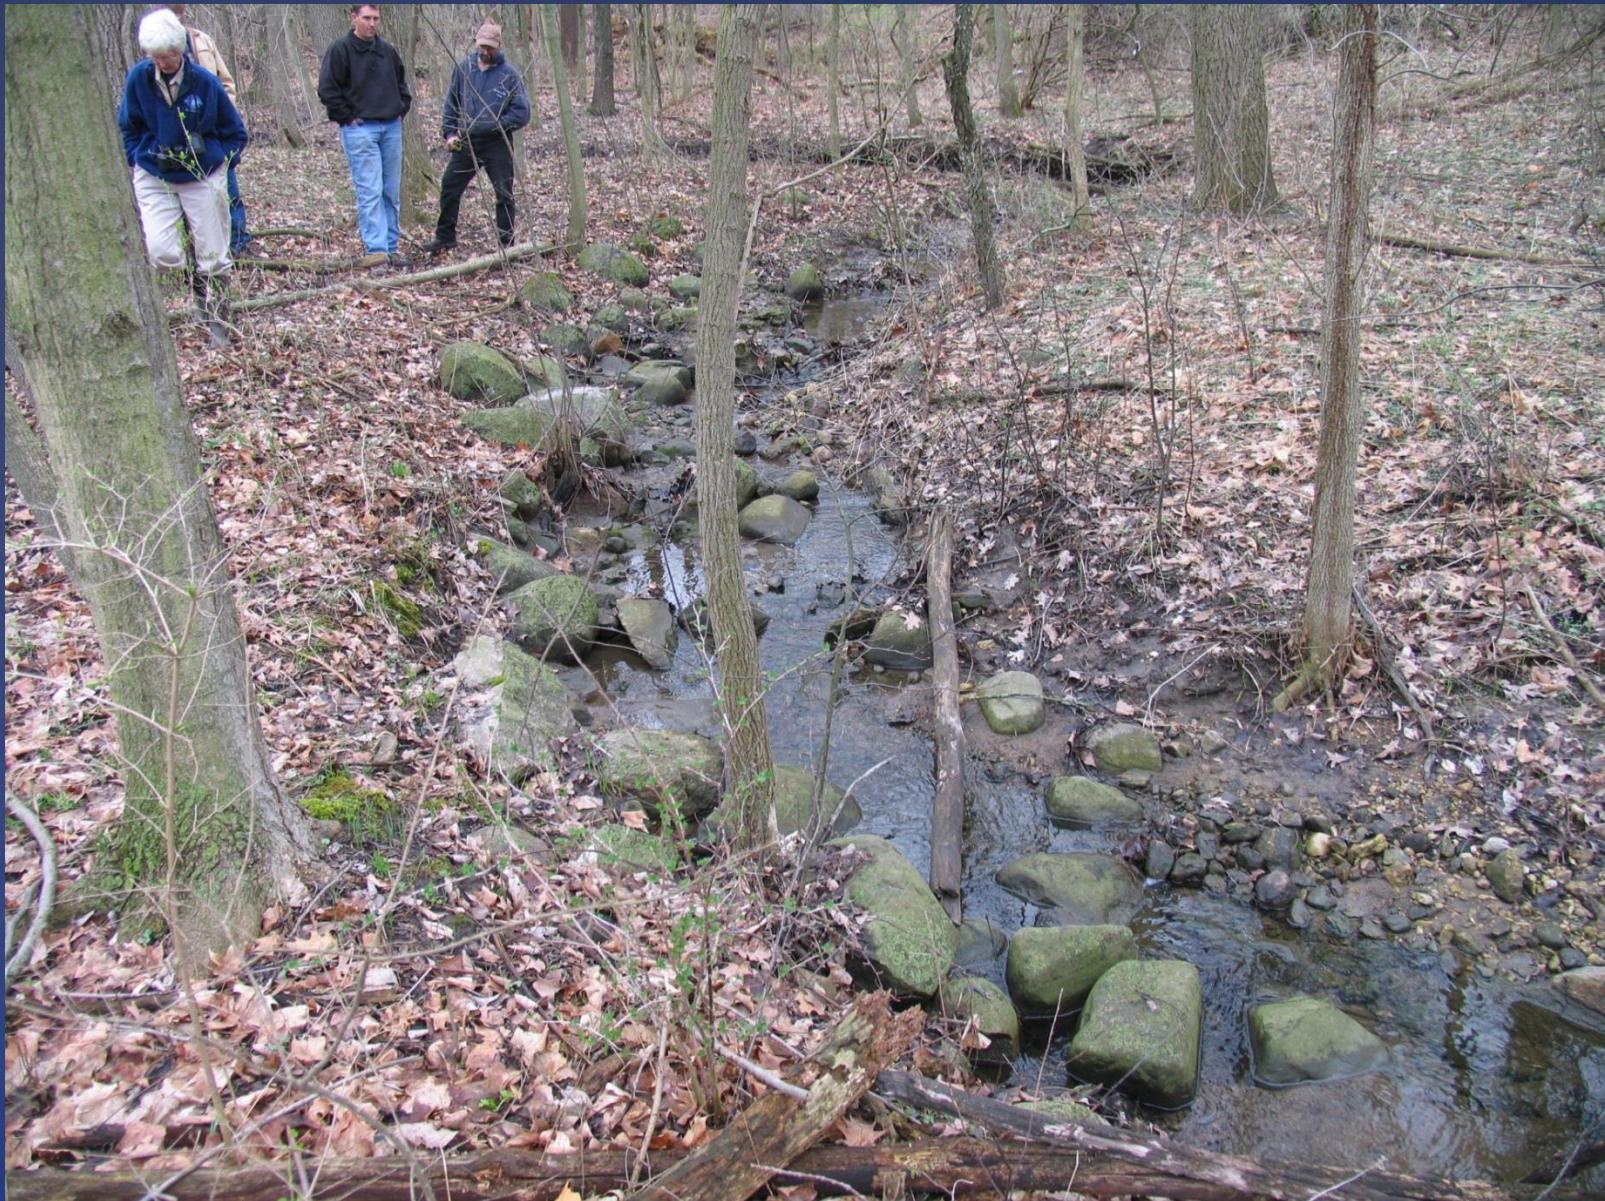
This short reach demonstrates that over time the creek would find material that would stabilize the bed just as we planned to do with our structures.

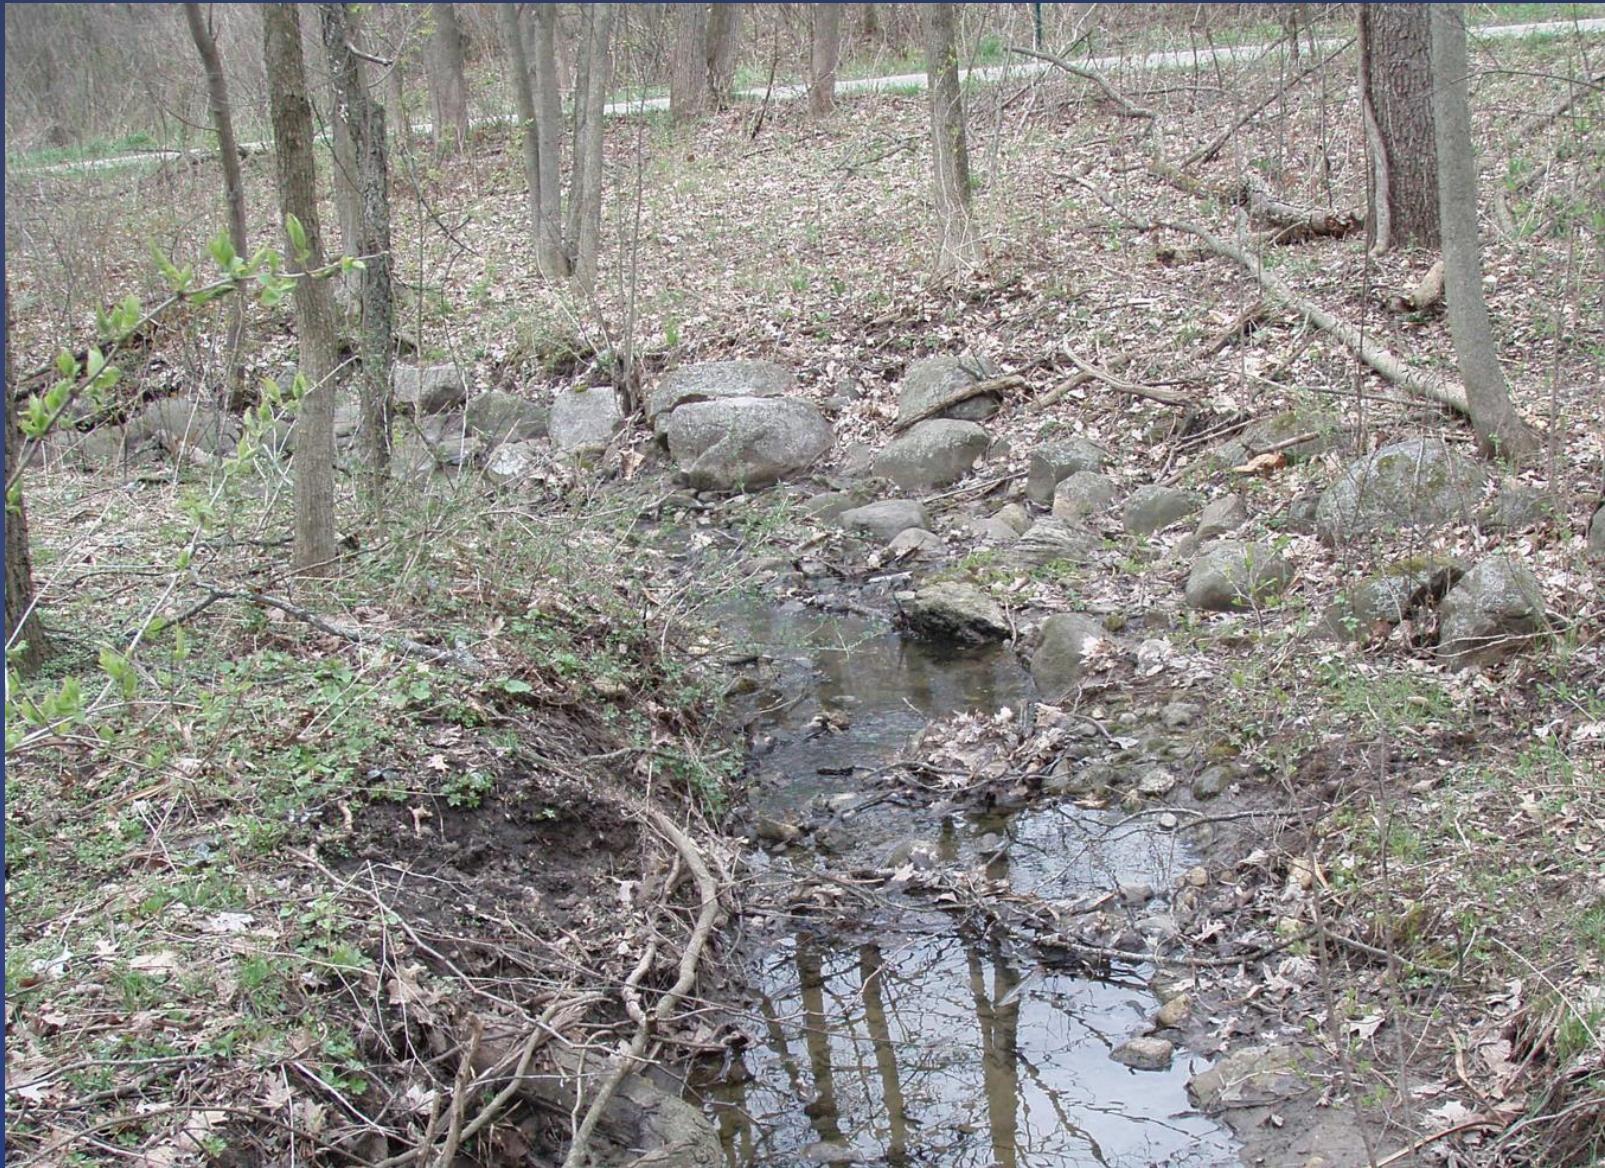
This short reach exhibits a naturally armored bank which we hoped to replicate in our restoration efforts.
