NORRIS WOODS CREEK STABILIZATION AND WATER QUALITY IMPROVEMENT PROJECT

Norris Woods Creek Stabilization
and
Water Quality Improvement Project

Soil Erosion and Sediment Control Plan

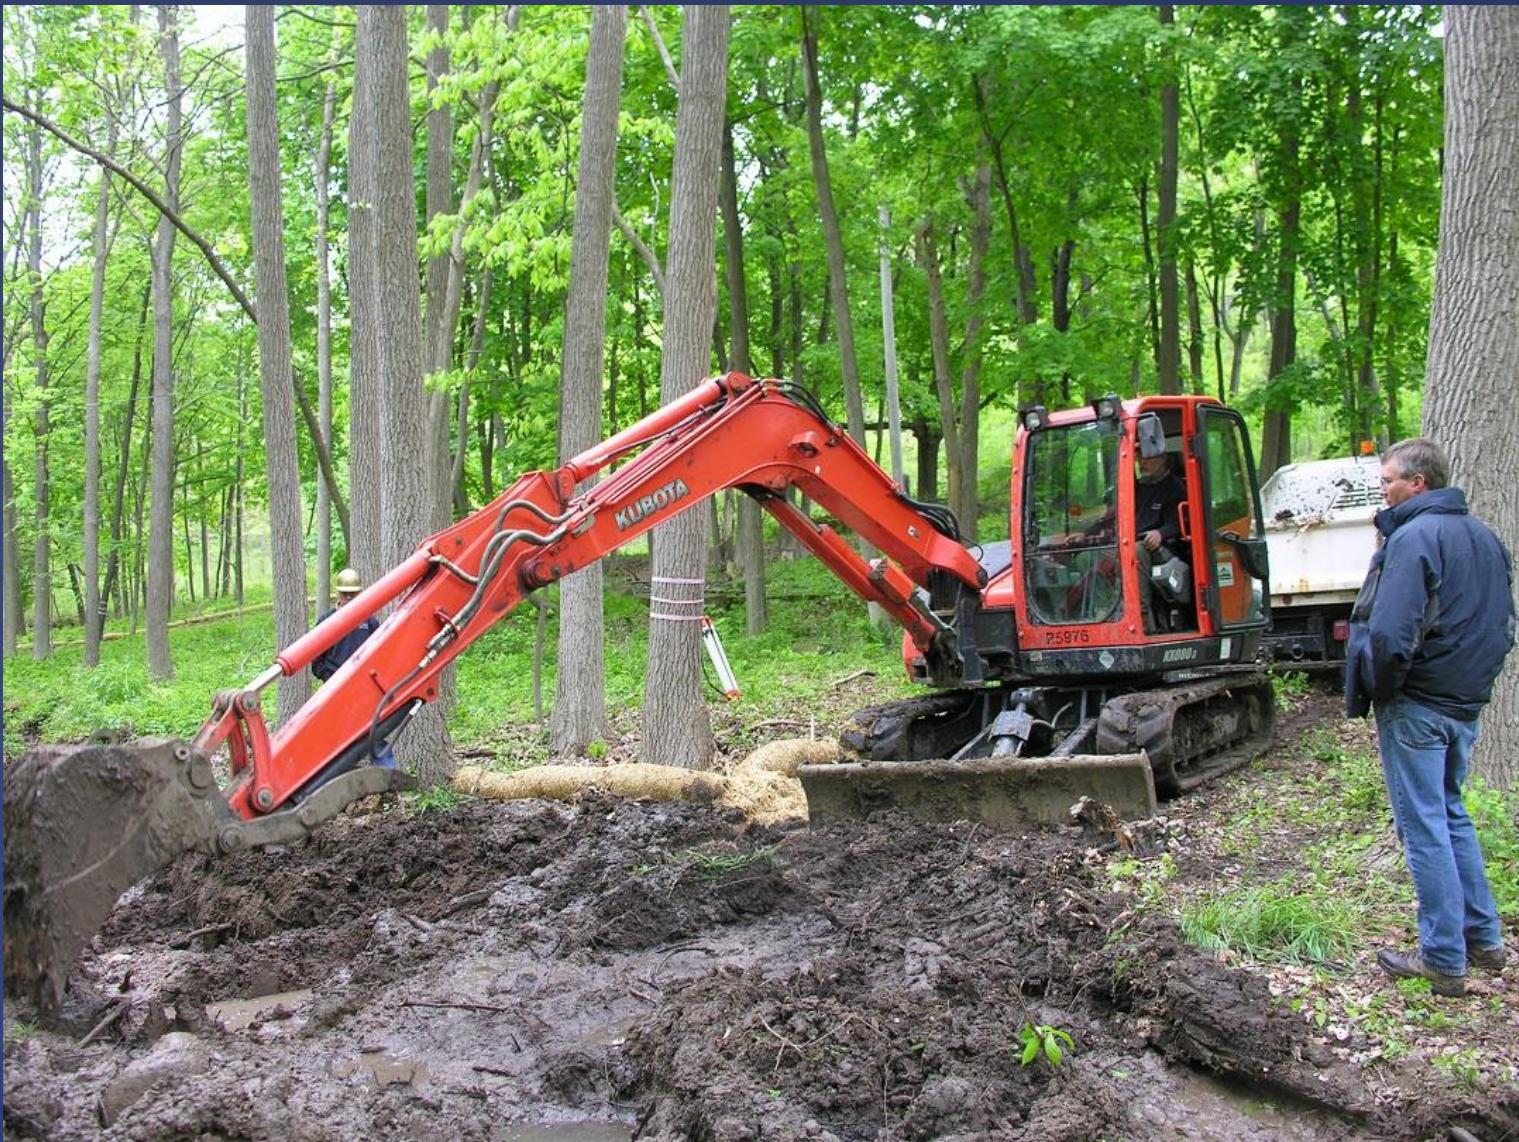
Conditions in the spring were so wet that it made it nearly impossible to move equipment and materials.

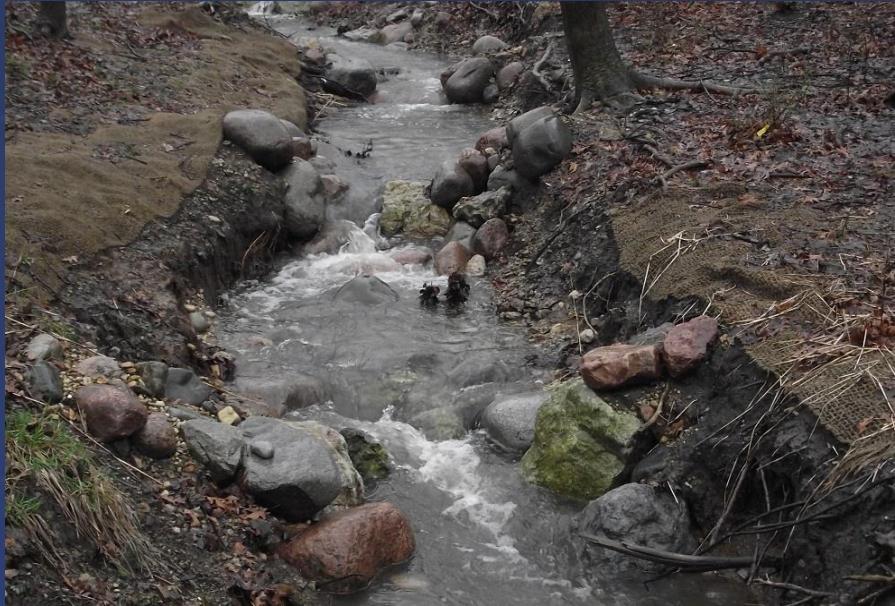
Step pool structures doing what they do

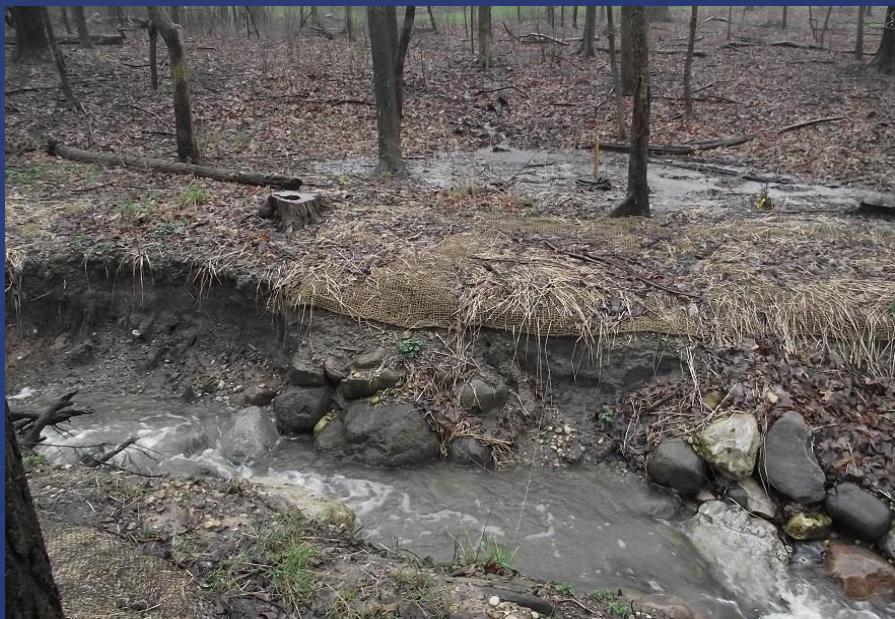
The weeping wall

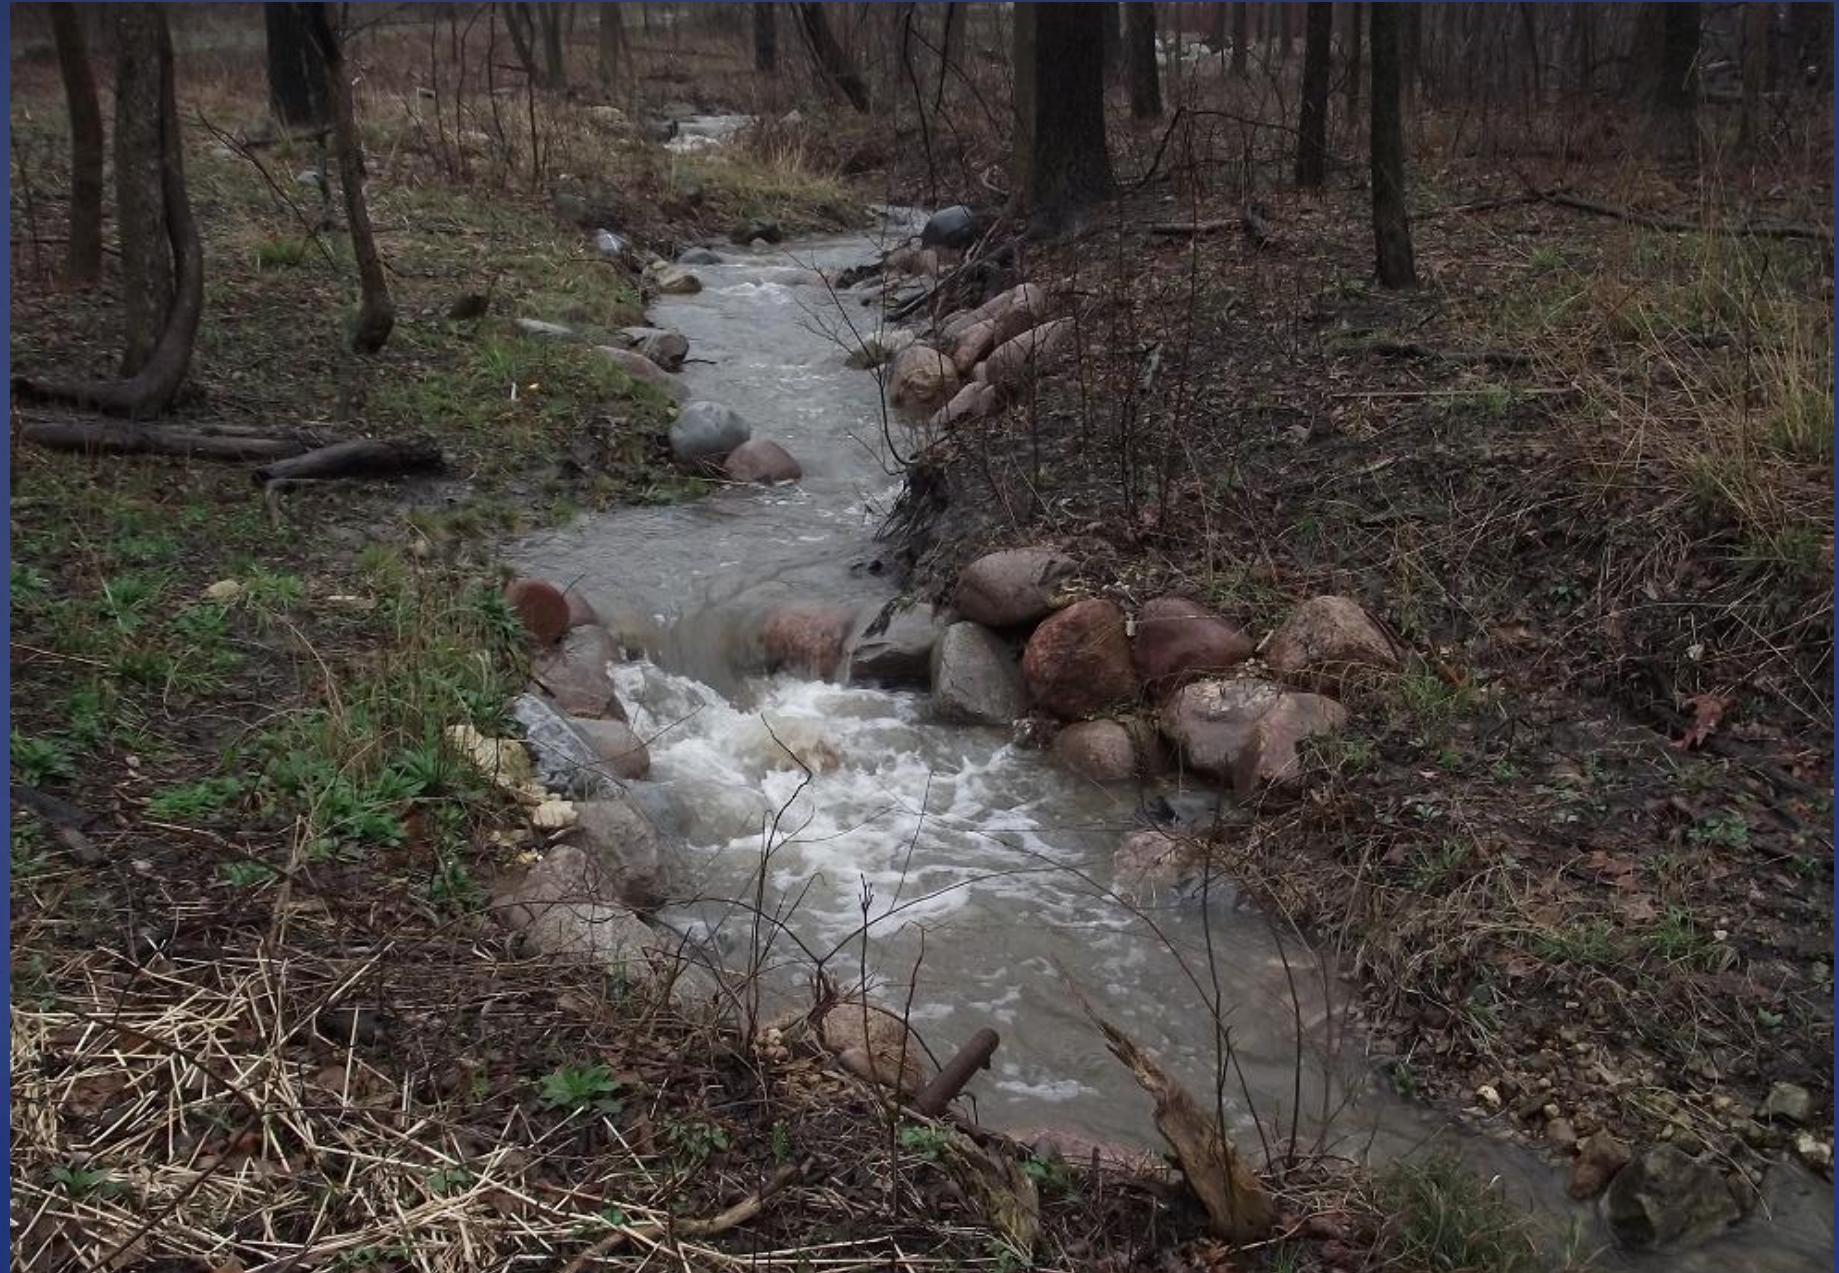
All of the storm water energy is right where we want it.
